# Fault-code troubleshooting with Jaltest

One of the most frequent faults in Cummins ISX engines fitted with exhaust aftertreatment systems is the fault code 2754 Pressure sensor in the emissions filter. Valid data, but above normal operational range.

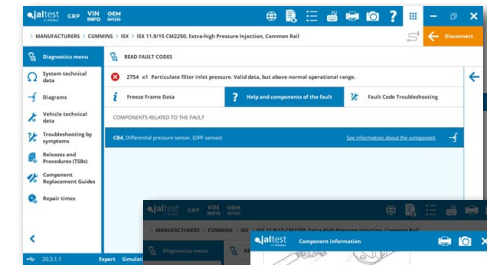
05

Jaltest fault code troubleshooting guides provide freeze frame data (pic 4) and information about the component/s to be verified that may be damaged and that could have generated the fault code in the memory of the ECU (pic 5). In addition, they indicate the location (pic 7), the component connection and, of course, the technical specifications (pic 6).

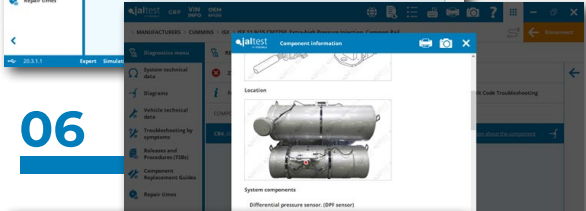
06

These specify the range of permissible values for the component so the component that needs to be replaced can be easily verified.

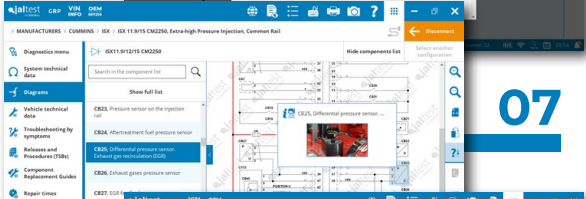
07

In addition to all of this, the technical information offered by Jaltest includes wiring (pic 7) and operation diagrams, troubleshooting by symptoms (pic 8) and repair releases, plus procedures and verification procedures such as the information needed to perform a valve adjustment (pic 9). Owing to an excessive amount of soot in the DPF, the engine control unit (ECU) disables the possibility of launching a regeneration either manual or forced via a diagnostic tool.

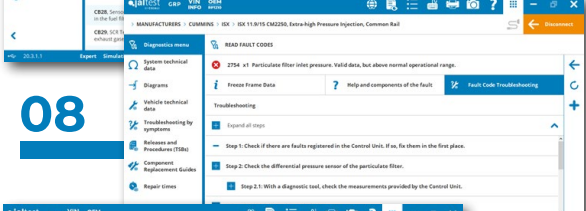
08

Jaltest says its fault code troubleshooting guides (pic 8) are a great example of this.

These specify, step by step, the actions that must be taken by the technician to isolate the cause of the fault and take the corresponding measures in the shortest possible time, helping them to avoid unnecessary costs and replacement of parts.

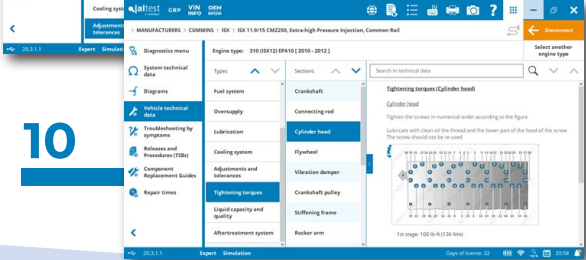
10

**Tightening torques (Cylinder head)**

Tighten the screws in numerical order according to the figure

Lubricate with clean oil the thread and the lower part of the head of the screw  
The screw should not be re-used

1st stage: 100 lb-ft (136 Nm)
